Edmiston Spring Channel Enhancement
Summary Report
January 2019

Appendix A
Edmiston Springs Photo points

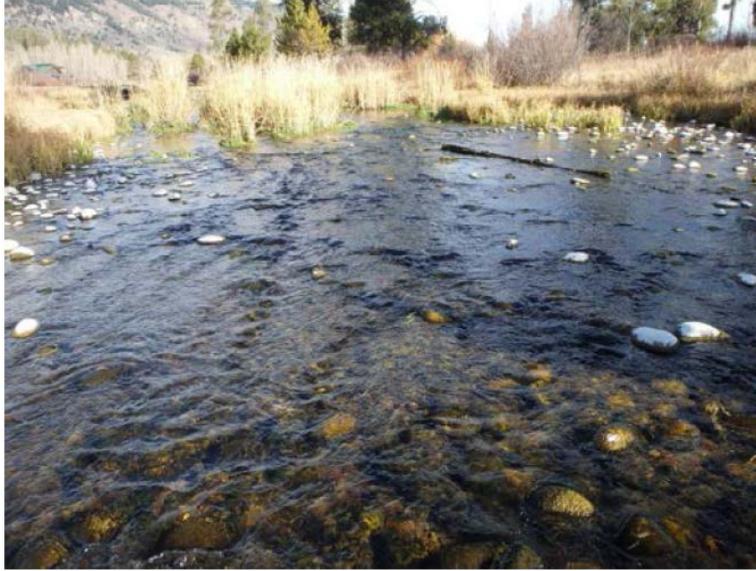
Habitat Unit #2 – Low Gradient Riffle (10/30/2014)

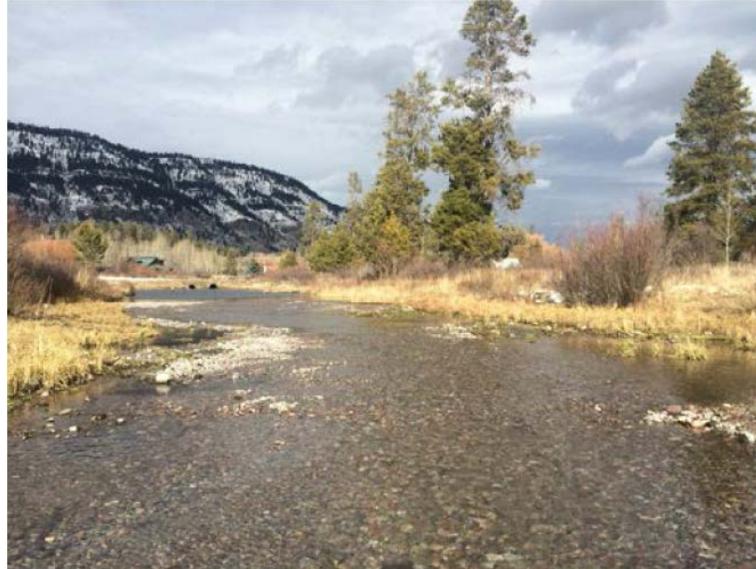
Habitat Unit #2 – Low Gradient Riffle (12/09/2015)

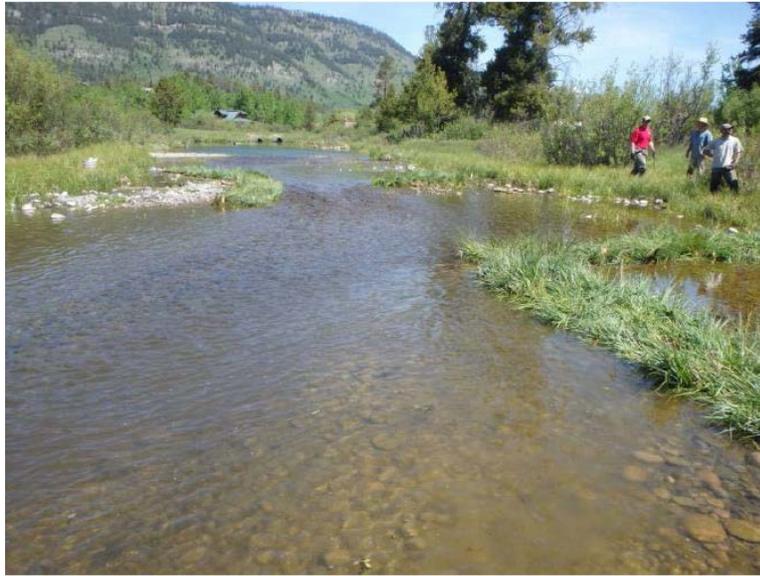
Habitat Unit #2 – Low Gradient Riffle (12/09/2015)

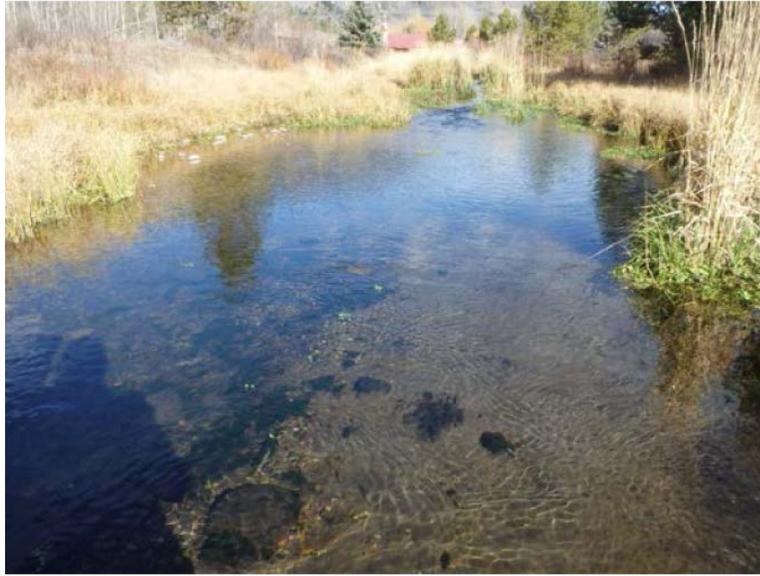
Habitat Unit #5 – Low Gradient Riffle (10/30/2014)

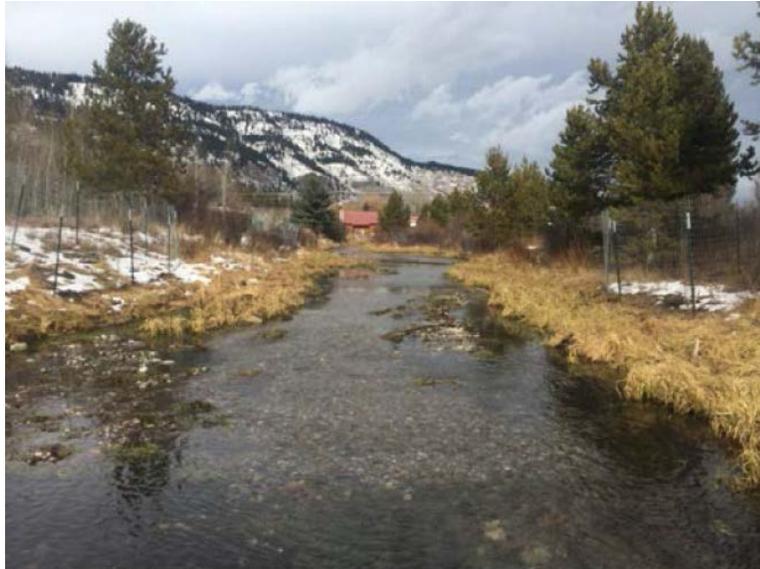
Habitat Unit #5 – Spawning Riffle with Excavated Pools (12/9/2015)

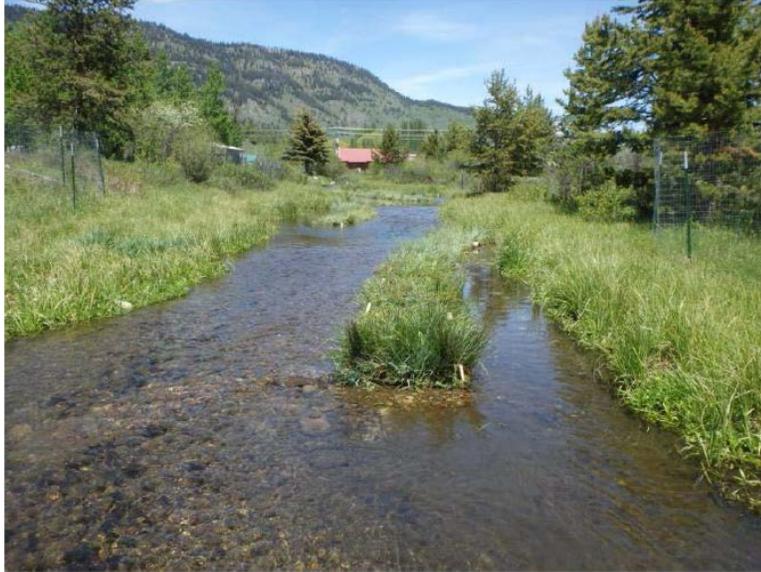
Habitat Unit #5 – Spawning Riffle post Sod Placement (6/1/2016)

Edmiston Spring construction was completed in 2016. Final touches included the placement of wetland sod berms within the active channel throughout the project reach. These treatments concentrate flows within the channel and delineate flowing from back water habitats.

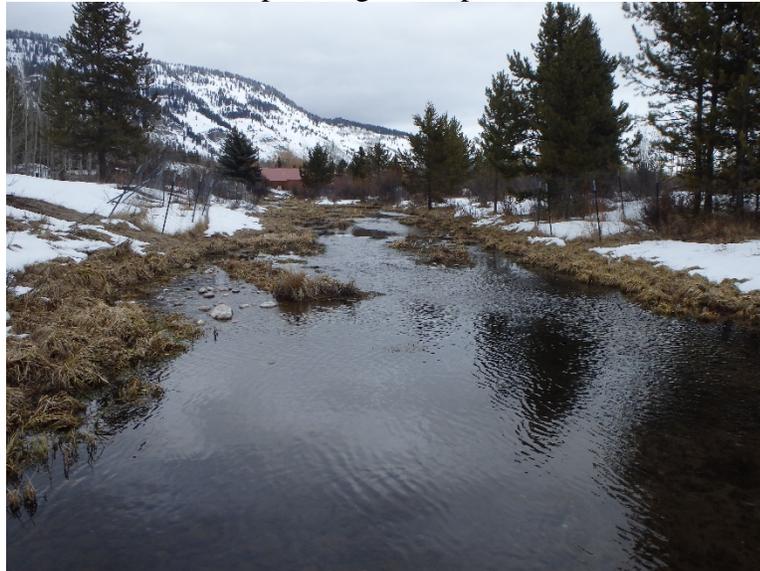
Habitat Unit # 5 – Spawning Riffle post Sod Placement February 2018

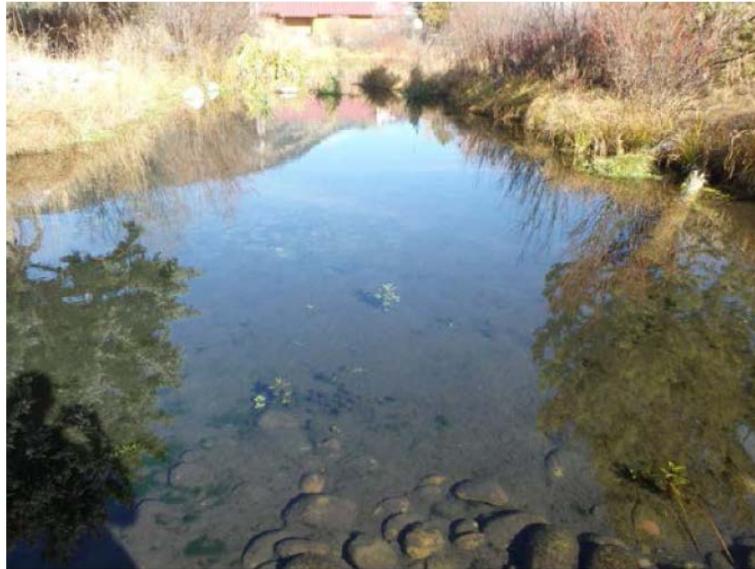
Habitat Unit #6 – Glide (10/30/2014)

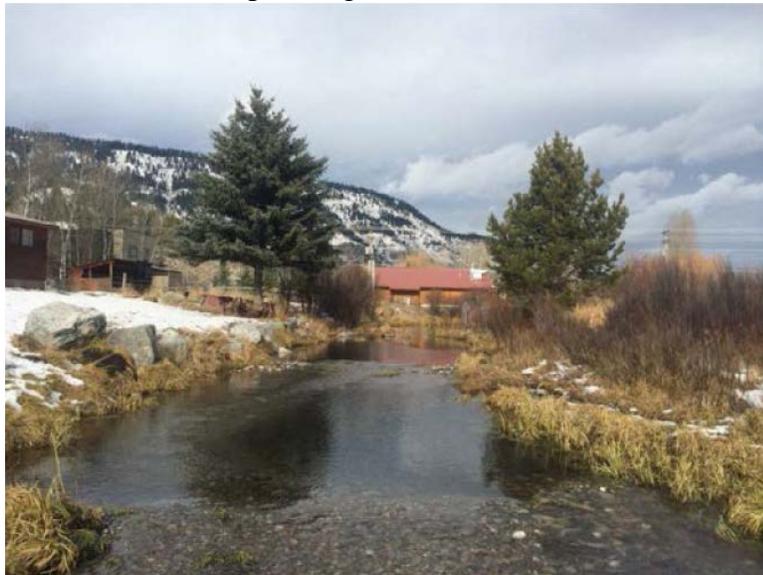
Habitat Unit #6 – Spawning Riffle (12/9/2015)

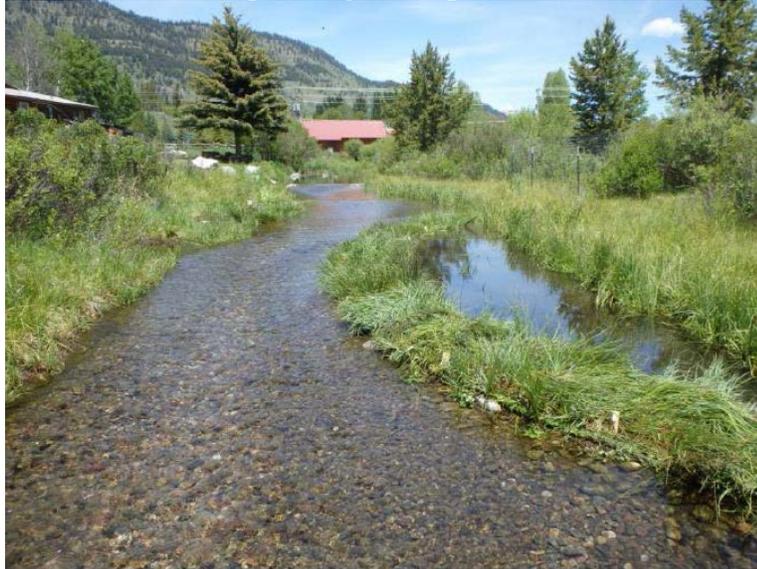
Habitat Unit #6 – Spawning Riffle post Sod Placement (6/1/2016)

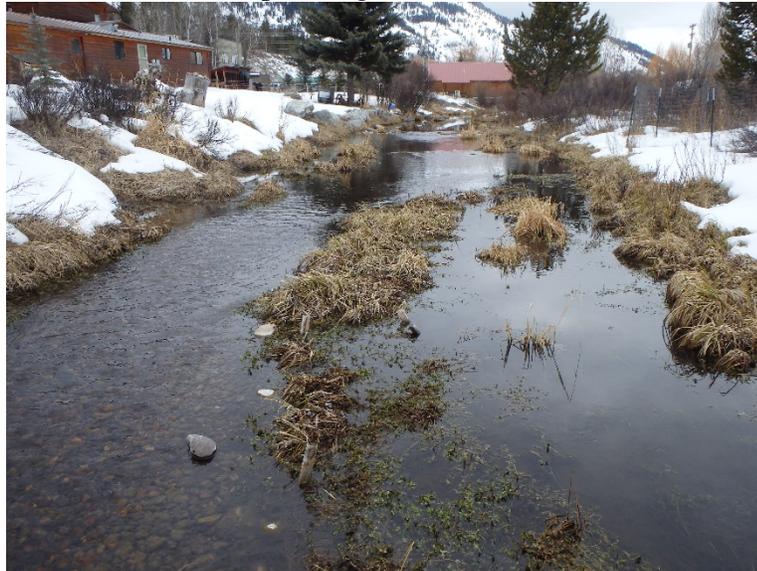
Habitat Unit # 6 – Spawning Riffle Post Sod Placement February 2018

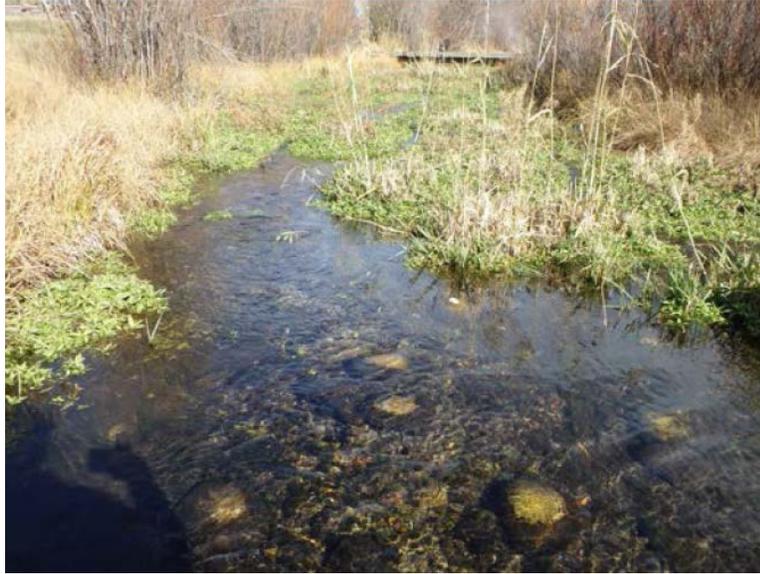
Habitat Unit #11 – Low Gradient Riffle (10/30/2014)

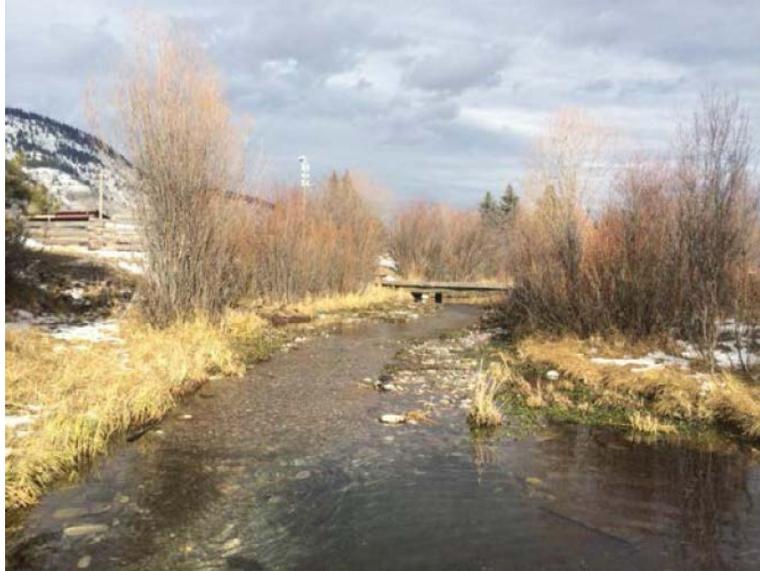
Habitat Unit # 11 – Spawning Riffle with Excavated Pools (12/9/2015)

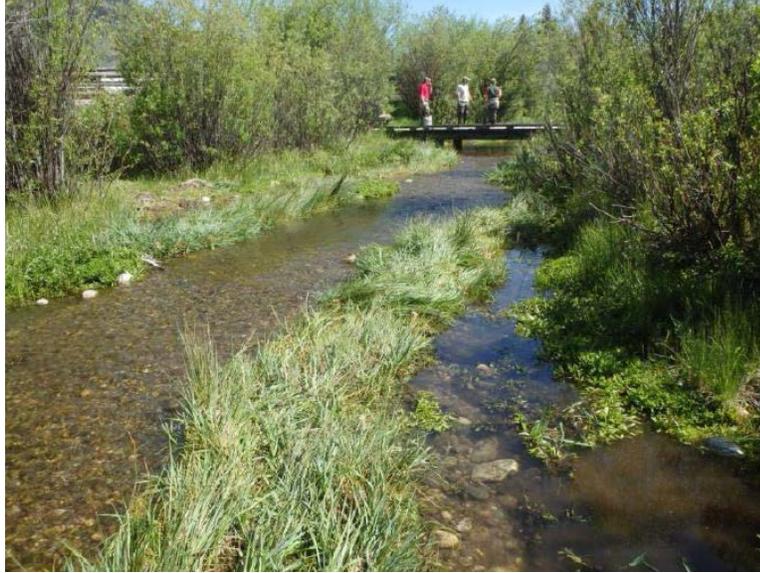
Habitat Unit #11 – Spawning Riffle with Excavated Pools post Sod Placement
(6/1/2016)

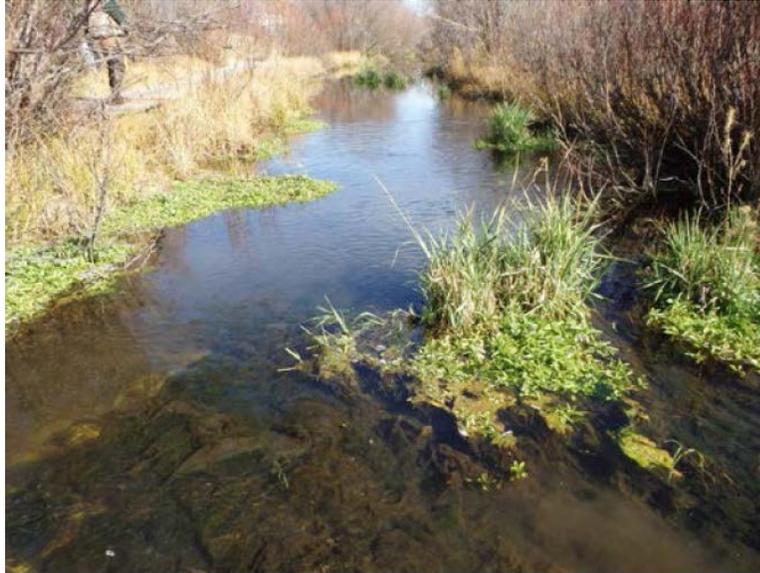
Habitat Unit #12 – Glide looking upstream from bridge (10/30/2014)

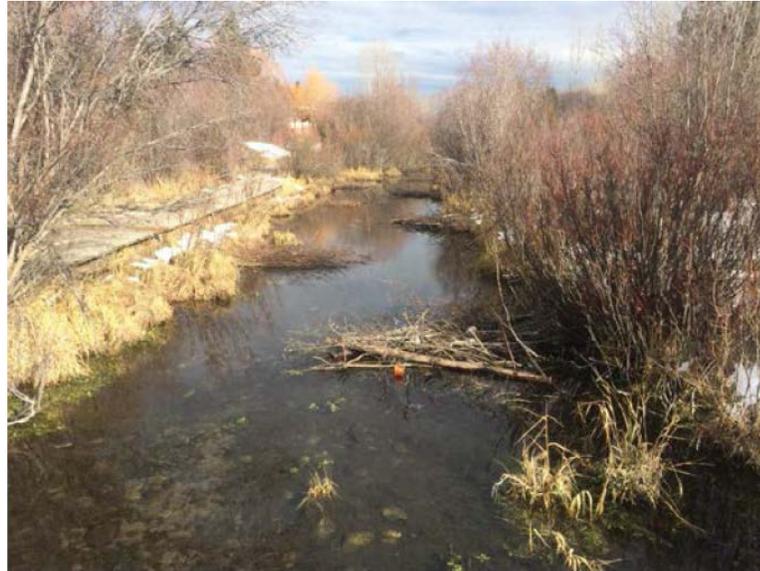
storage activities. Sediment inputs appear to be settling in willow structures and filling in interstitial spaces that would otherwise be occupied by small fish. However, over time, these sediment deposits may form point bars and encourage willow growth. Establishment of mature riparian vegetation would further delineate stream flows and provide additional habitat benefits in the form of overhead cover, terrestrial invertebrate inputs and temperature regulation.

Habitat Unit #12 – Slash Piles and Brush Mattresses added (12/9/2015)

Monitoring consisted of three tasks: redd counts, photo points, and electrofishing of willow slash and mattress structures (see Habitat Unit # 12, Appendix A).

Table 1. Willow slash cluster and mattress fisheries sampling 2016-2018. The number of fish of each species, Brook Trout (*Salvelinus fontinalis*, BKT) and Snake River Cutthroat Trout (*Oncorhynchus clarkia*, SRC) sampled from constructed willow structures (See Habitat Unit # 12, Appendix A) are reported. Twelve willow slash cluster and/or mattress structures were sampled upstream of the Edmiston Spring Highway 22 road crossing.

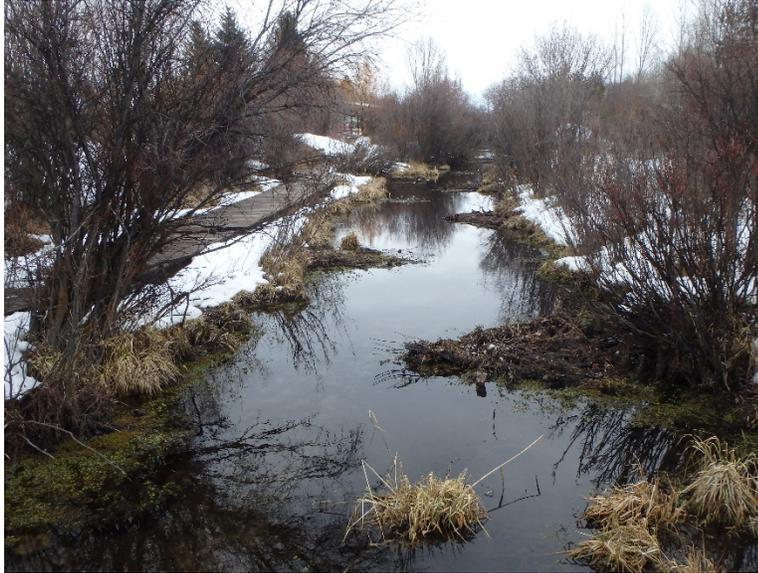
Habitat Unit # 12 – Slash Piles and Brush Mattresses February 2018

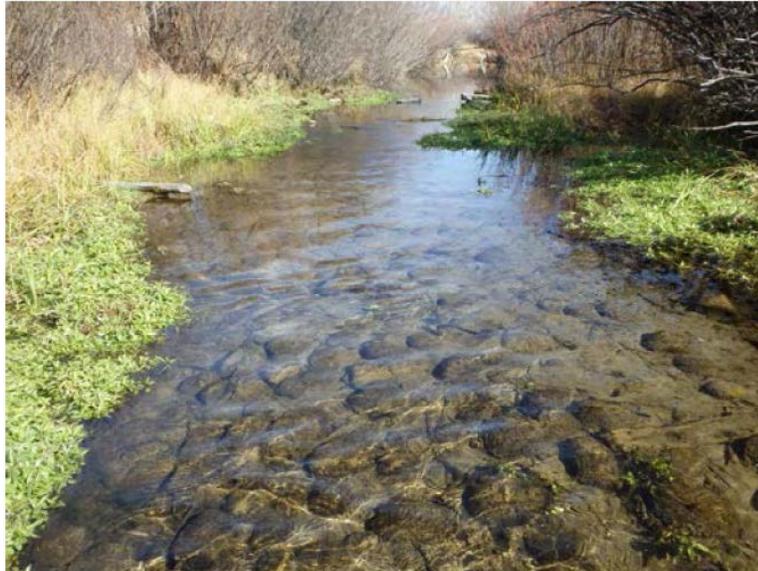
Habitat Unit # 13 – Low Gradient Riffle (10/30/2014)

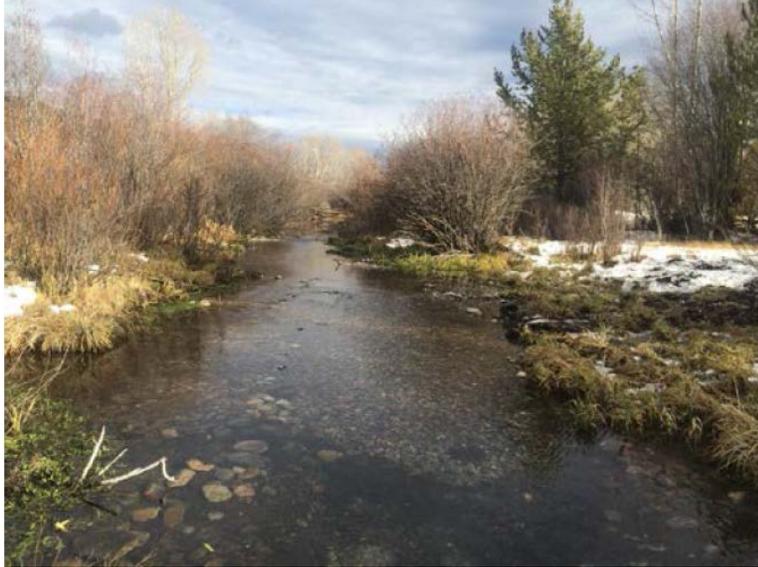
Habitat Unit # 13 – Spawning Riffle and Excavated Pool (12/9/2015)

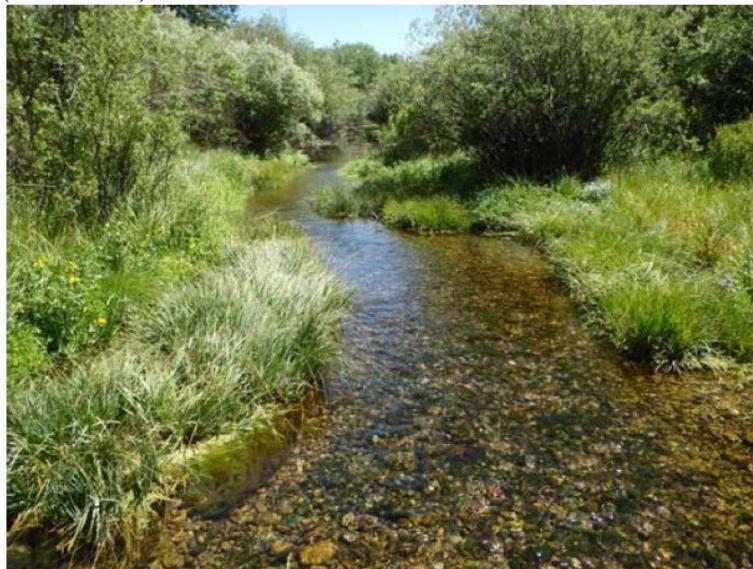
Habitat Unit #13 – Spawning Riffle and Excavated Pool post Sod Placement
(6/24/2015)

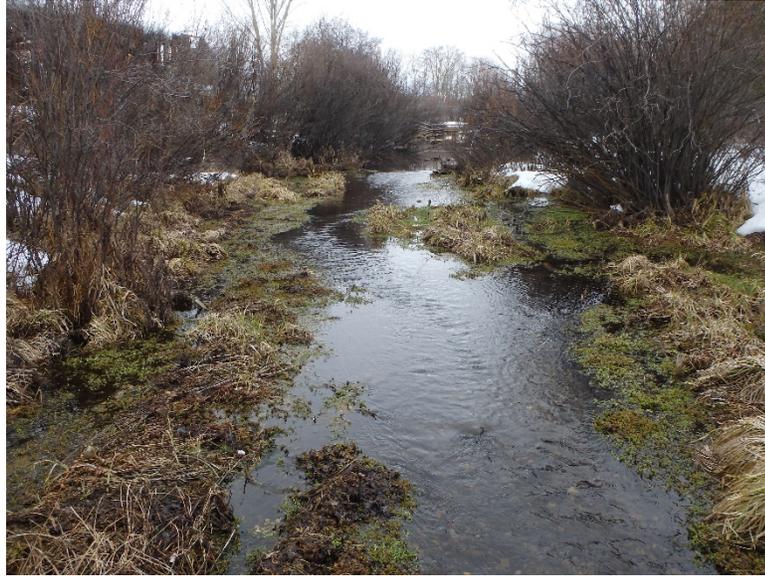
Habitat Unit # 13 – Spawning Riffle and Excavated Pool post Sod Placement
February 2018

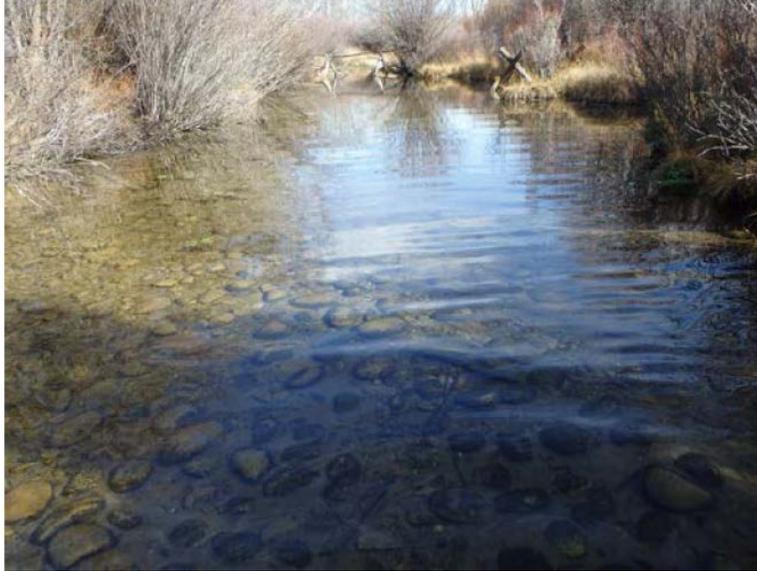
Habitat Unit #14 – Glide (10/30/2014)

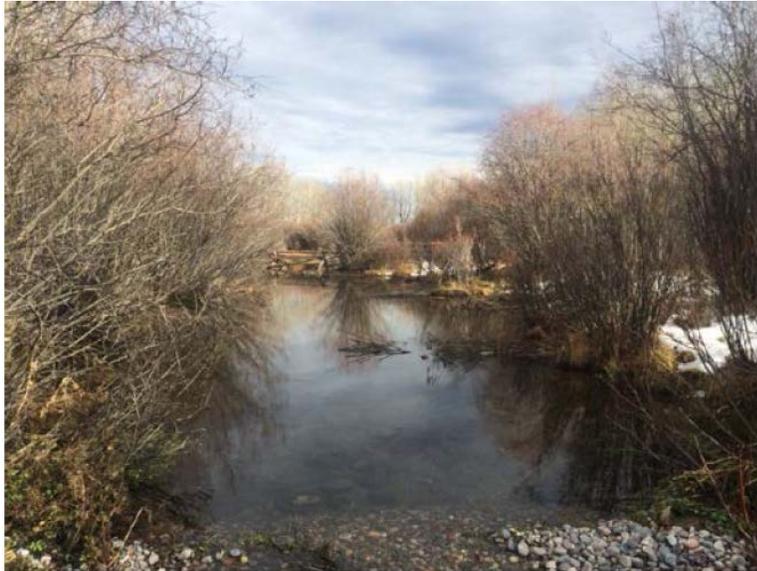
Habitat Unit #14 – Slash Piles and Willow Mattresses added (12/9/2015)

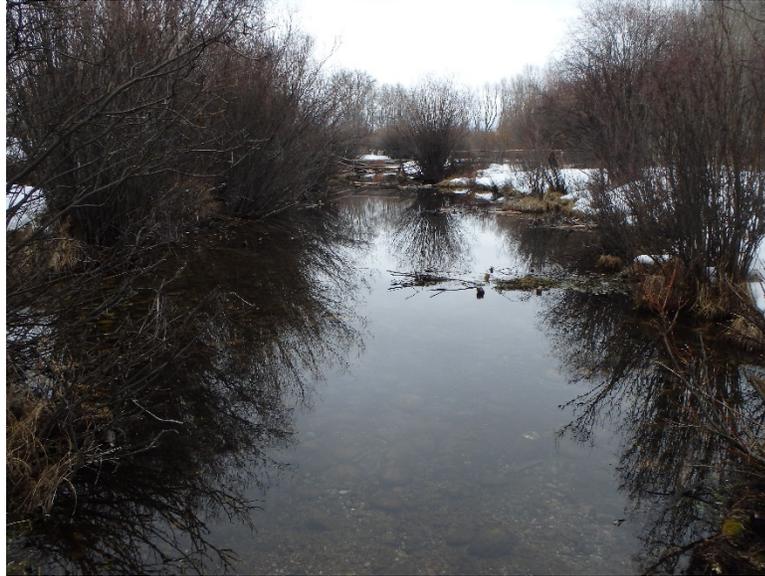
Habitat Unit #14 – Slash Piles and Willow Mattresses February 2018
